INEEL/EXT-99-00743 (Rev 1)

November 1999

Status and Estimated Life of the 300,000-Gallon INTEC Tanks

**Idaho National Engineering and Environmental Laboratory
High Level Waste Program Division
Bechtel BWXT Idaho, LLC
Idaho Falls, Idaho 83415**

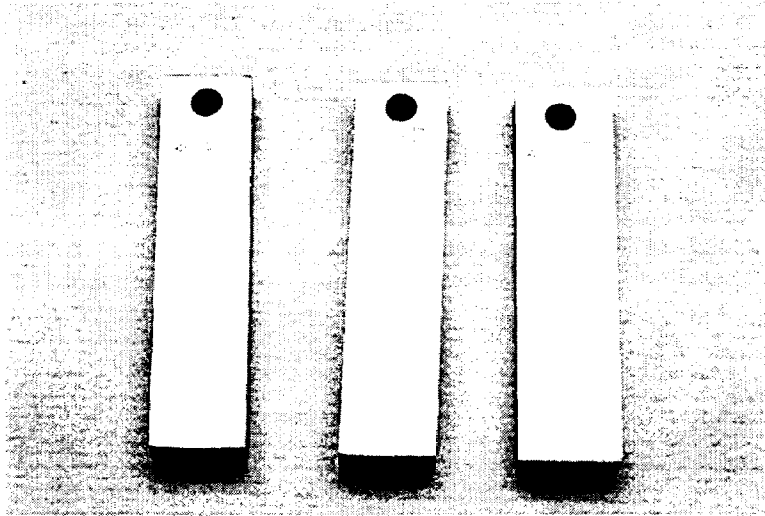
Figure 5. Hastelloy C-22, Uniform Corrosion, Tested per ASTM G28-97, Method A

Figure 5 shows three coupons of Hastelloy C-22 (Nickel-Chromium-Molybdenum alloy) material that have undergone corrosion testing in a standard corrosion test (Reference 4, ASTM G 28, Method A) for nickel based alloys. The samples have undergone uniform corrosion with no localized pitting or cracking and retain much of their original metallic luster. The average corrosion rate was 28 mils per year. These coupons were tested in the solution annealed condition.

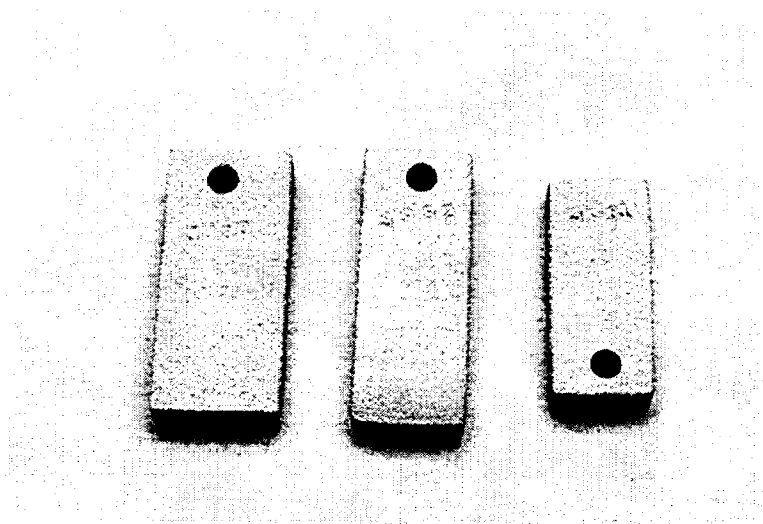
Figure 6. Hastelloy C-22, Intergranular Corrosion

Figure 6 shows intergranular corrosion damage of Hastelloy C-22 corrosion coupons that were heat treated at 649°C for 1072.25 hours and tested in ASTM G 28, Method A. The surface is extremely rough and the measured corrosion rate was extremely high at 1307 mils per year. The effect of holding the metal at a temperature in the sensitizing range for a sufficient time can be seen by comparing these coupons with the coupons in Figure 5.

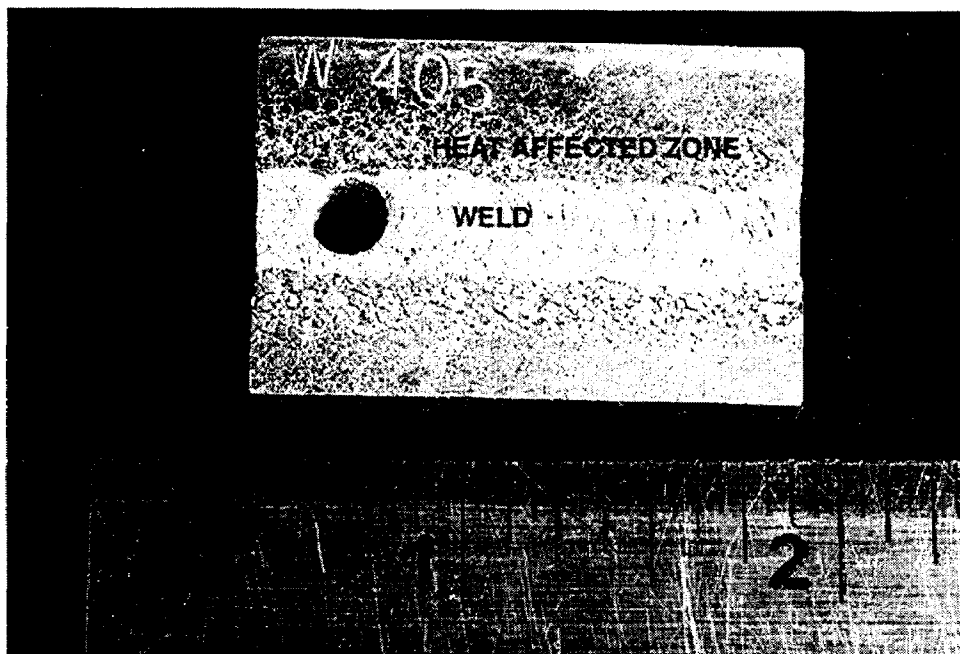
Figure 7. Intergranular Corrosion in the Weld Heat Affected Zone

Figure 7 shows the intergranular corrosion of a Nickel-Chromium-Molybdenum alloy (Allcor) in the weld heat affected zone. The severe localized corrosion around the metal grains is evident.

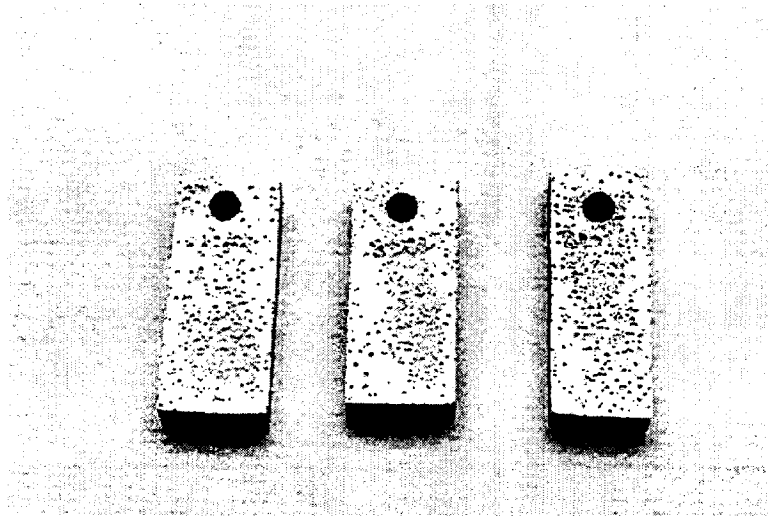
Figure 9. Hastelloy C-22, Pitting, Tested in ASTM G28, Method B

Pitting is another form of localized corrosion that can affect stainless steels and other alloys that rely on a passive film for corrosion protection. It is characterized by damage at discrete sites on the surface. The pits visible on the surface may have larger areas of internal damage. The local breakdown of the passive layer will be facilitated by chloride ions at metallurgical imperfections. These imperfections may be non-metallic inclusions, localized changes in metallurgical structure from heating cooling cycles (surface grinding) and surface deposits. Figure 9 shows three Hastelloy C-22 coupons that were tested per the requirements of ASTM G 28, Method B (Reference 5). The coupons show massive pitting that would obviously reduce the wall thickness.

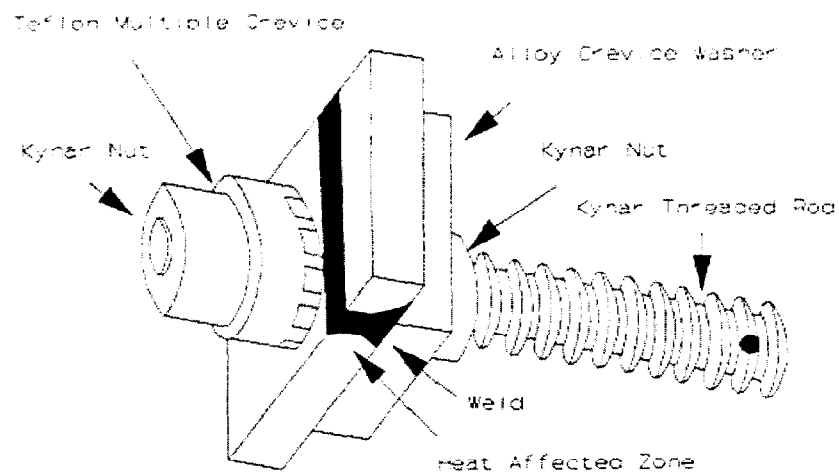
Figure 16. Crevice Corrosion Test Assembly

Crevice corrosion can occur in stainless steels where there is metal-to-metal contact or metal-to-non-metal contact where there is shielding of a surface from the corrosive solution. To illustrate this, examples of crevice corrosion observed in a corrosion test program are provided. Figure 16 shows the corrosion coupon test assembly where the stainless steel sample has a non-metallic washer with crevices in it fastened on the coupon surface. This testing is based on ASTM G 78-95 (Reference 6). Figure 17 shows a stainless steel coupon that was exposed to a solution containing a high chloride level. The coupon shows localized damage from the effect of the crevice on the surface from the washer.

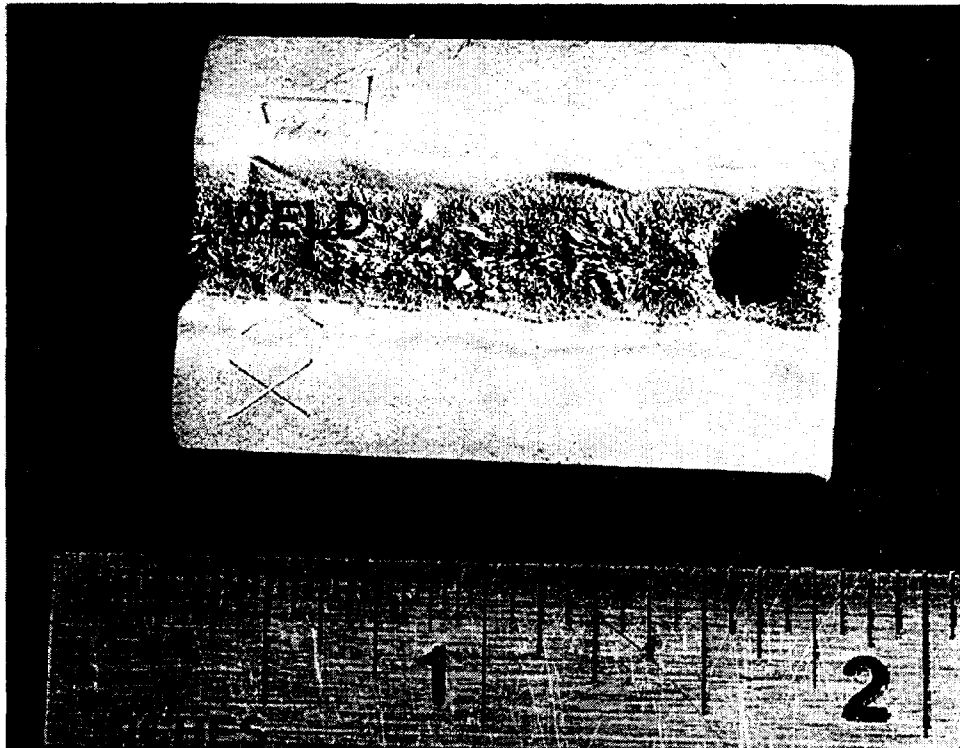
Figure 18. Galvanic Corrosion, Accelerated Weld Metal Corrosion of Inconel 690

One additional type of corrosion that could occur in the waste tanks is galvanic corrosion between the base metal plates used for the tank wall and the weld metal. The result would normally be an accelerated corrosion of the weld metal where it would corrode at a faster rate than the tank wall material. This would be considered an unusual case, but could occur if the as-deposited weld metal chemistry would make it inferior in corrosion resistance to the base metal. An example of this is shown in Figure 18. The material is Inconel 690 (Nickel-Chromium-Iron) which was exposed to a boiling Nitric Acid-Hydrofluoric Acid solution.

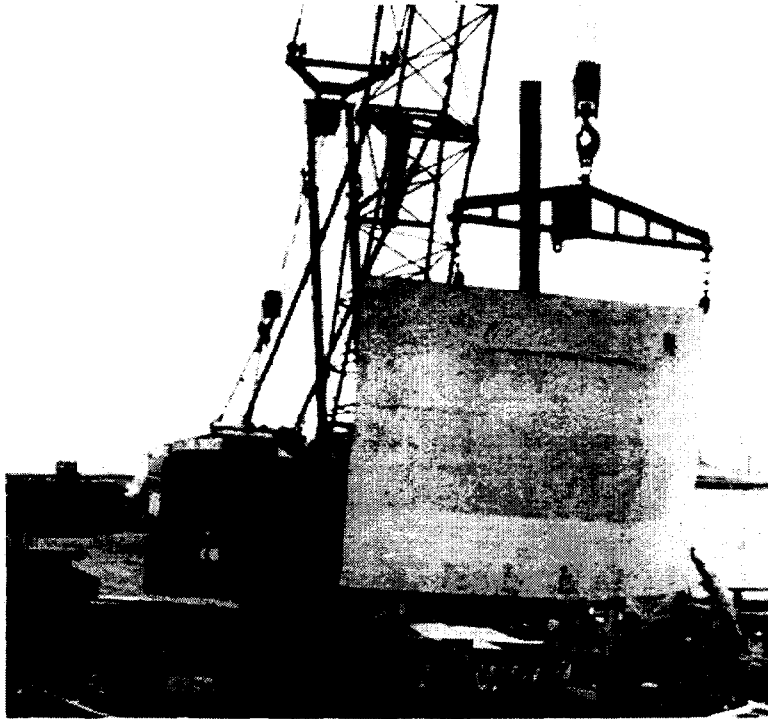
Figure 33. Lifting of Plate Section Showing Lifting Device

Figure 32 shows a horizontal weld. There are indentations in the plate next to the weld. These are believed to be marks where a mechanical lifting device fastened to the plate as shown in Figure 33. There are other spots on the surface that cannot be measured for convexity or concavity.
